In-situ X-ray microtomography characterization of damage in SiC_p/SiC mini-composites

To appear in: *Composites Science and Technology*

In-situ X-ray microtomography characterization of damage in SiC_f/SiC minicomposites

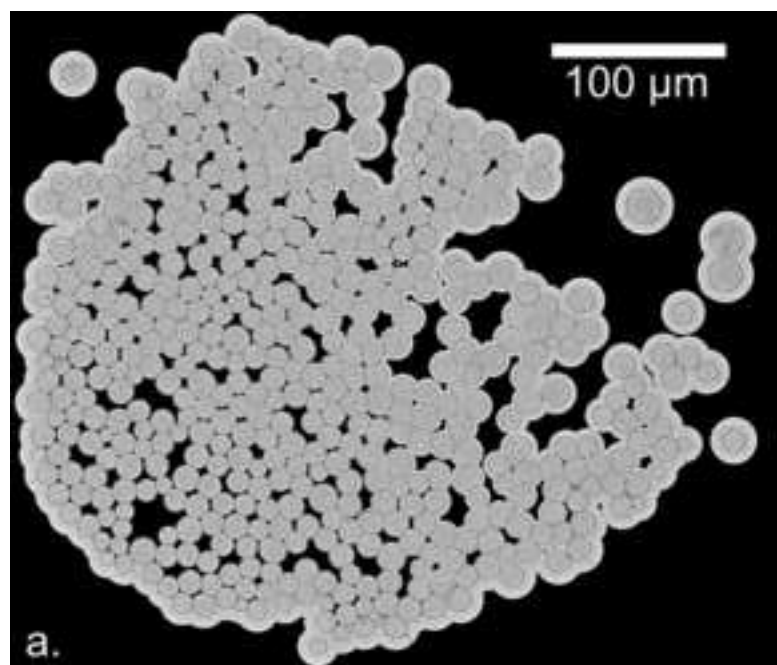
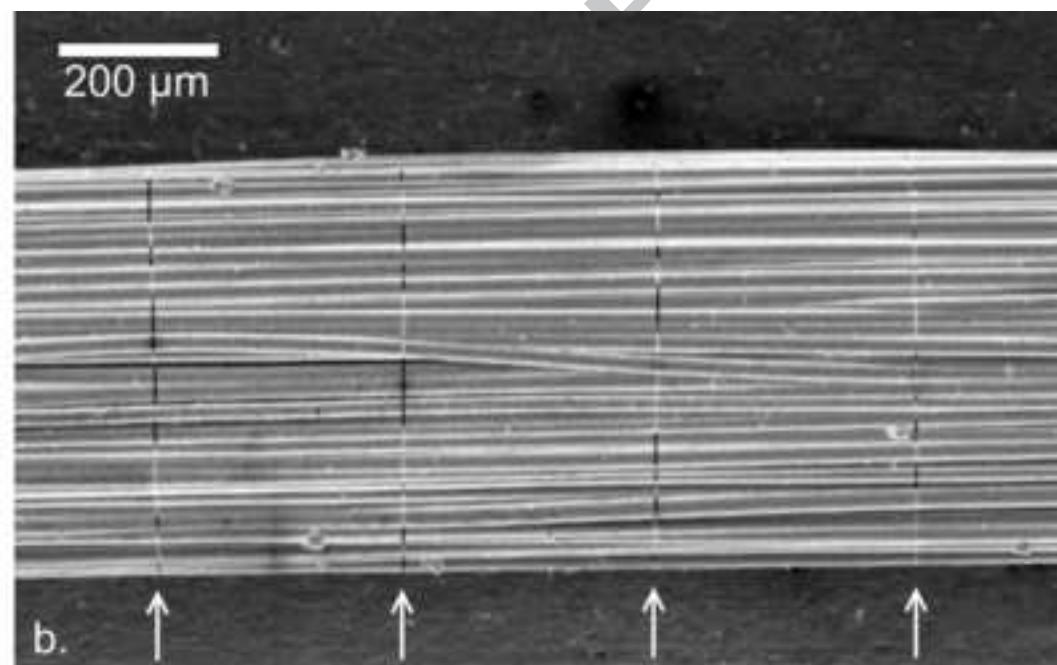
Figure 1

Figure 1: SEM micrographs of (a) minicomposite polished cross section; (b) cracked minicomposite under tension (75 N), arrows point out matrix cracks.

The residual porosity due to the CVI process, and fiber fractions were estimated at 0.12 (± 0.04) and 0.58 (± 0.09) from polished cross-section pictures (figure 1a).

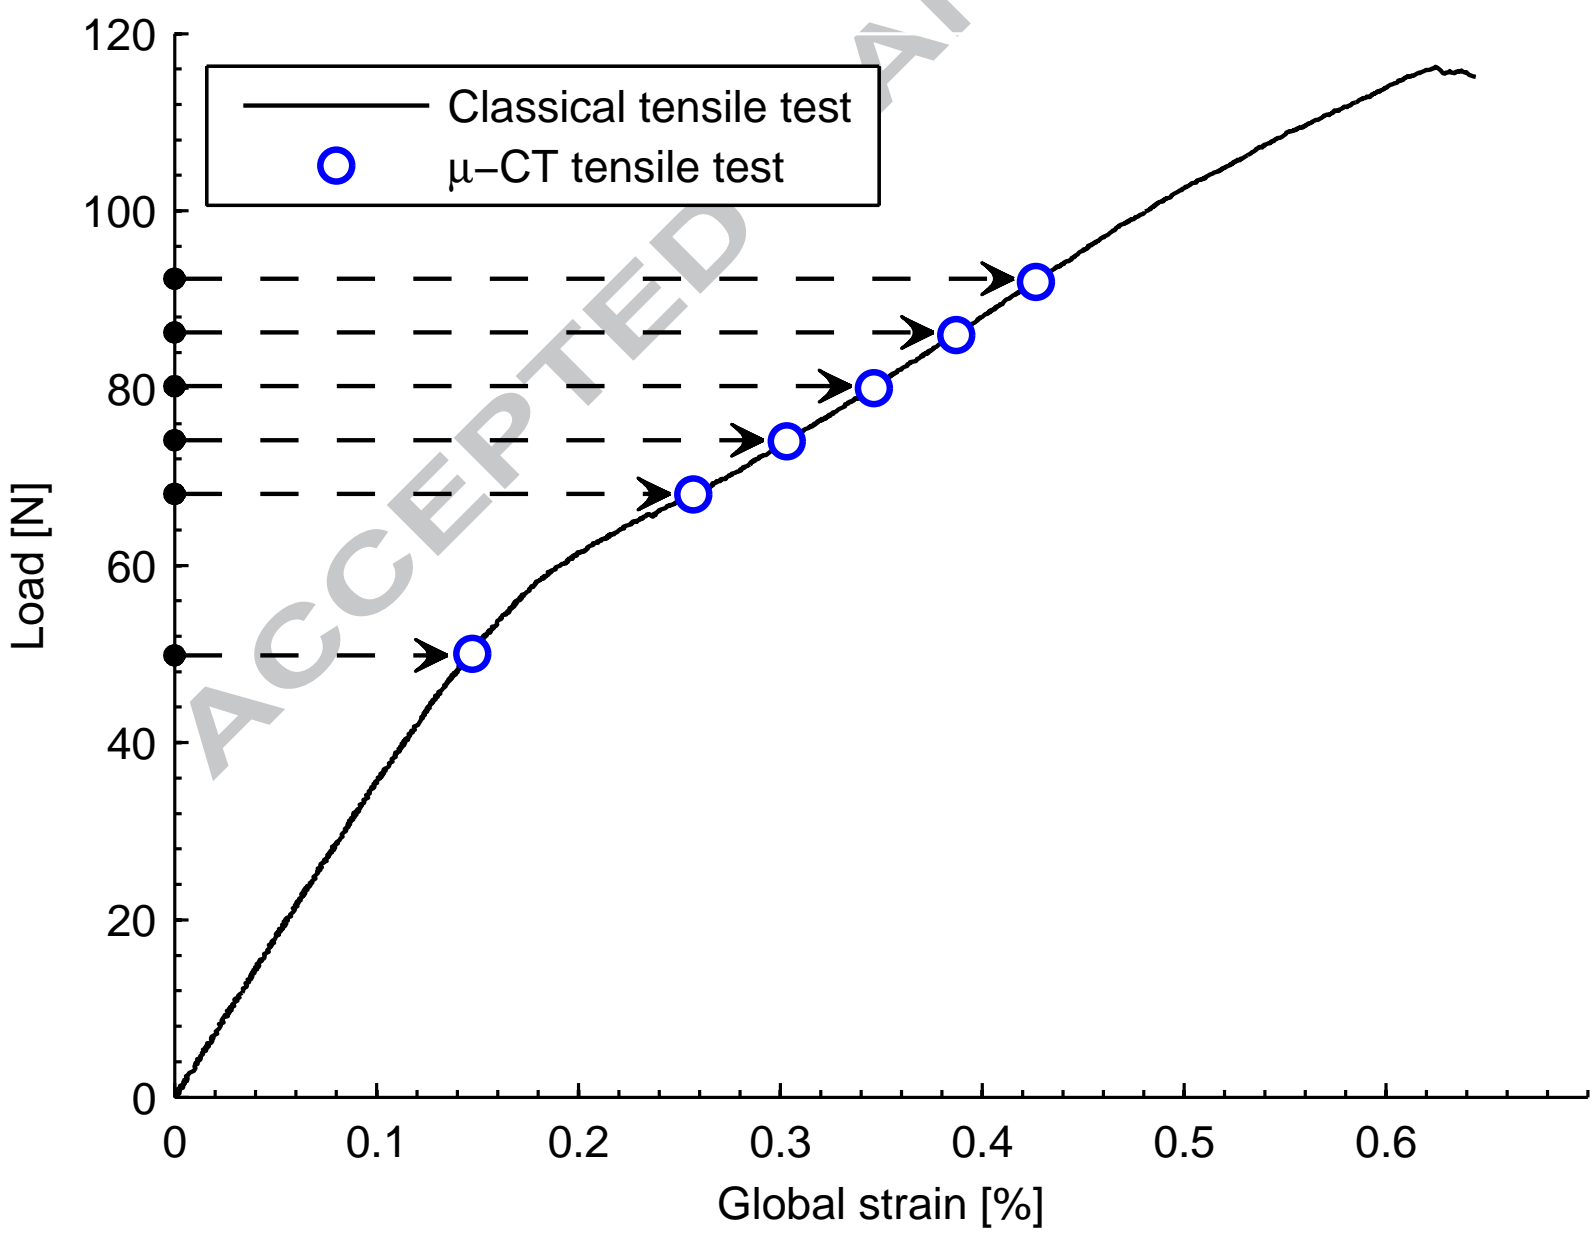
Figure 2

Like the woven composite, minicomposites have an elastic, damageable behavior. Their macroscopic behavior (figure 2) follows typical successive steps in accordance with damage evolution [3, 12]. The first one is an elastic domain of the minicomposite behavior: no cracking occurs. A second nonlinear step is associated with the matrix cracking (figure 1b) until saturation of crack number density (reached for a total strain of about 0.3%). A second linear domain associated with the additional elastic deformation of fibers is then observed after matrix crack saturation. The final step is characterized by a slight nonlinearity associated with fiber breaking just before the ultimate failure (close to $\approx 0.7\%$).

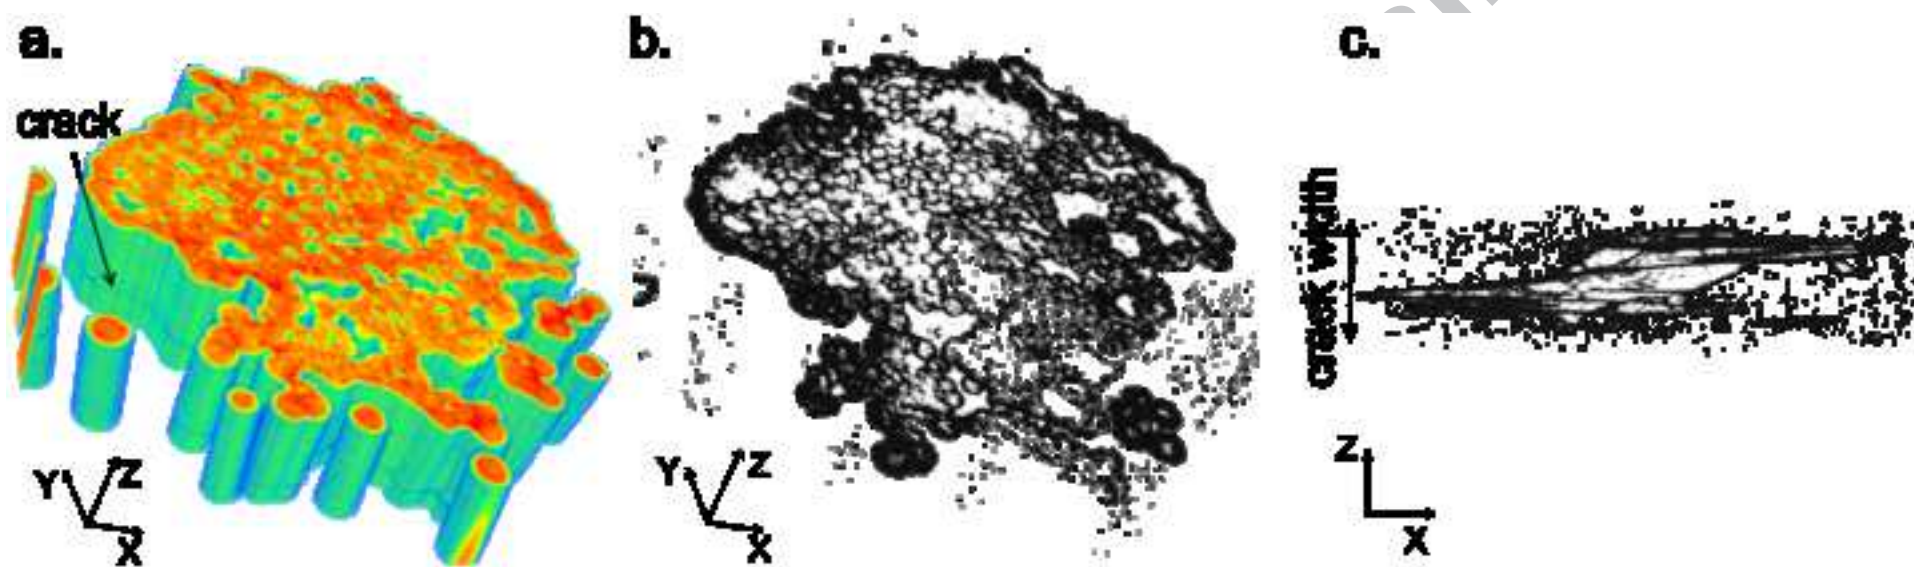
Figure 3: (a) Sub-volume containing a matrix crack; (b-c) Detected matrix crack from two different angles of view.

One goal of this study is to characterize the matrix crack morphology and its evolution with a load increase. Indeed, as presented in figure 3 (the detection procedure is detailed below), matrix cracks have a specific morphology which requires accurate locating. Such a result was obtained by spotting grey level variations in 3D images caused by the crack (figure 4). These variations could be visually noticed by routine observation of transverse slices of the tow. In the following, a “crack width” (along the axial direction) is defined from the number of transverse slices crossed by the crack (see figure 3). Note that crack openings cannot be characterized with accuracy because image resolution is not sufficient.

Considering a sub-volume containing a matrix crack (figure 1), the detection procedure is based on the processing of the grey level variation in the axial (Z) direction for all (X,Y) positions on the transverse plane. An example of such an evolution for a given (X,Y) position is provided in figure 5a. The crack leads to an important variation of the grey levels on a relatively short height among the three referenced reconstructions. The aim of the automatic procedure is to spot and locate this fluctuation in the axial direction, while reducing the detection of artifacts such as microstructure changes (matrix/pore interface) or image noise effects. Thus, a specific filter has been developed (figure 5b). It corresponds to the ratio of the norm of the grey level gradient along the Z-direction to the average derivative in a vicinity along Z (defined in figure 5a). In addition, the derivative was smoothed prior to the filtering in order to reduce the noise effect, using a centered moving average (10 voxels window along the Z-direction). A crack was then detected when the three global maxima (corresponding to the three reconstructions) of the filtered grey levels were separated by less than 10 voxels, ie 2.8 μm , which specifies the accuracy of the crack location. Otherwise, the material is considered healthy for the (X,Y) position and for all Z slices of the sub-volume. All (X,Y) positions are processed independently this way.

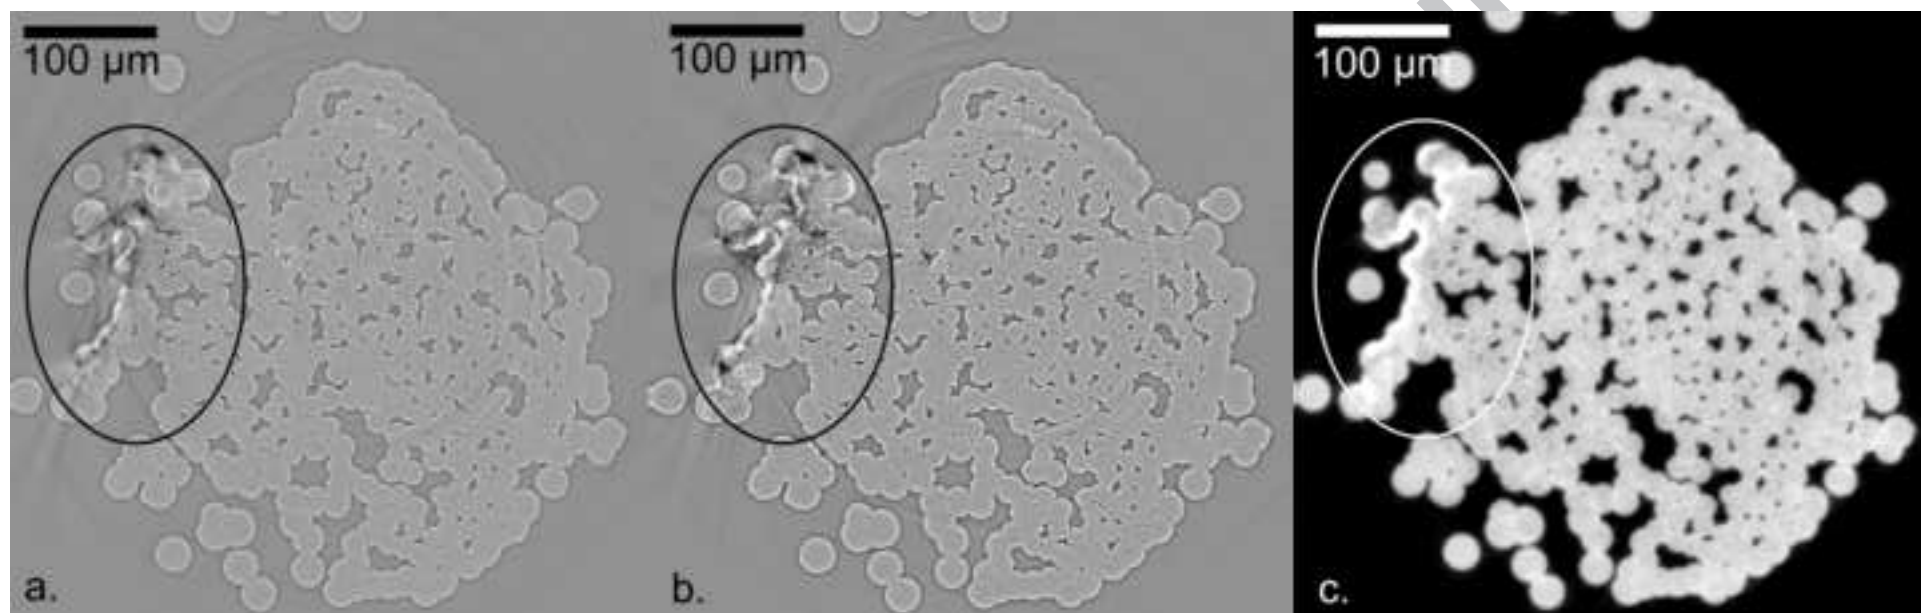
Figure 4

Figure 4: Reconstruction of a transverse slice in absorption contrast (first two distances) and holotomographic mode within a matrix crack.

crack edges, making a quantitative observation of the crack more difficult. Although the crack is less noticeable on holotomographic reconstructions, diffraction fringes do not appear on these reconstructed images (figure 4) as the reconstruction procedure takes into account their physical origin [15, 30]. In order to precisely locate the crack within the section, a specific procedure was established to automatically detect the cracks in the volume by combining the three distinct reconstructions.

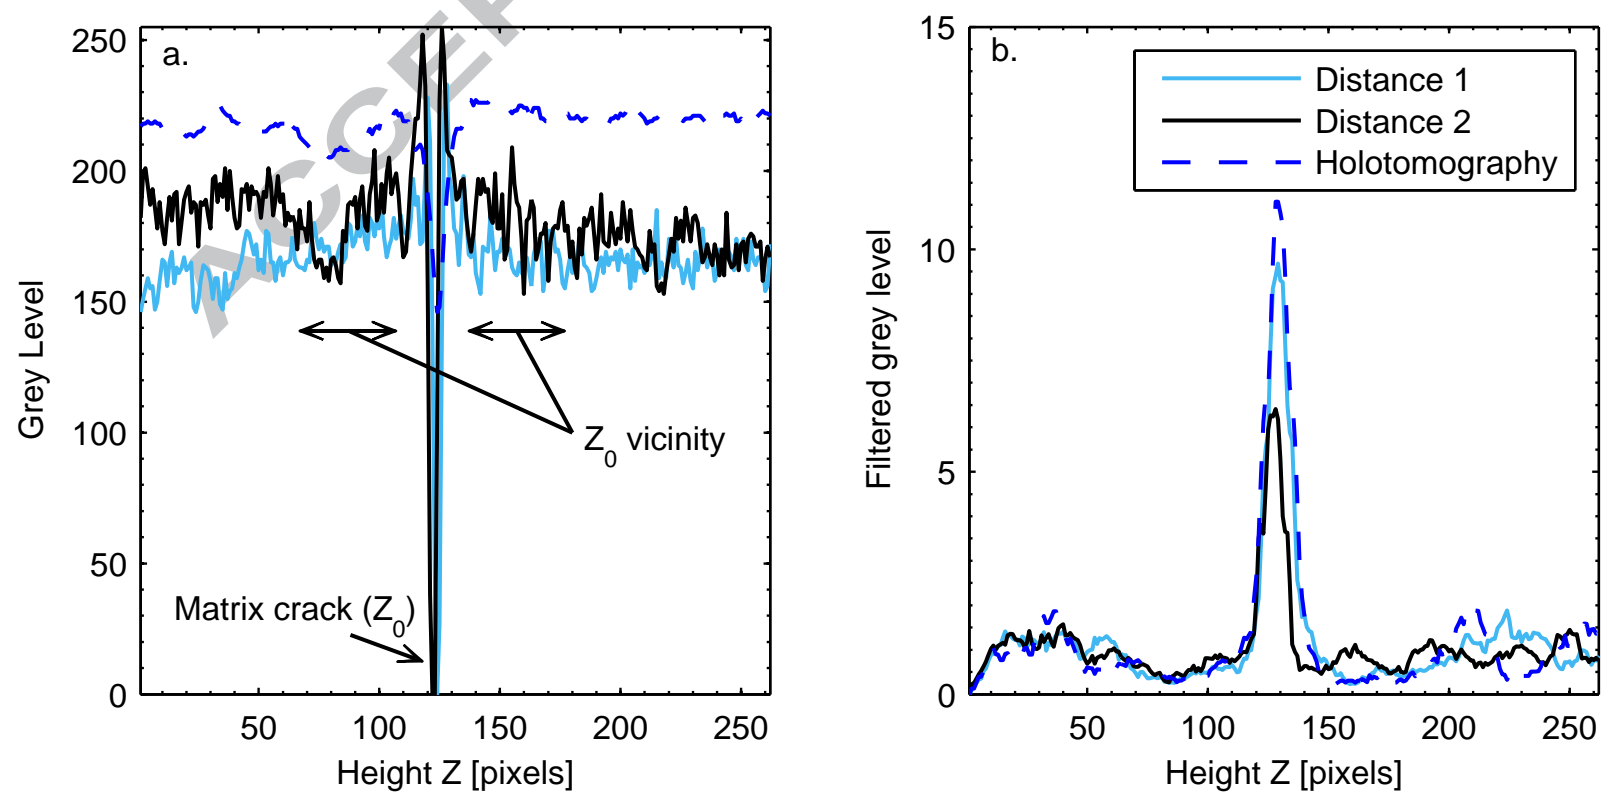
Figure 5

Figure 5: Filtering of grey levels : (a) grey level evolution in the fiber direction through a matrix crack; (b) filtering results.

Two preliminary comments can be made before going into detail. Firstly, projections of cracks 1 and 6 are less clear than others. Contrast variations (like the one presented in figure 5) were far less pronounced for these two cracks. This is probably a consequence of a smaller crack opening. Secondly, the minor crack 3b presented in figure 10 and main crack 3a are complementary. As presented in figure 8, the two cracked zones were independent before the last loading step.

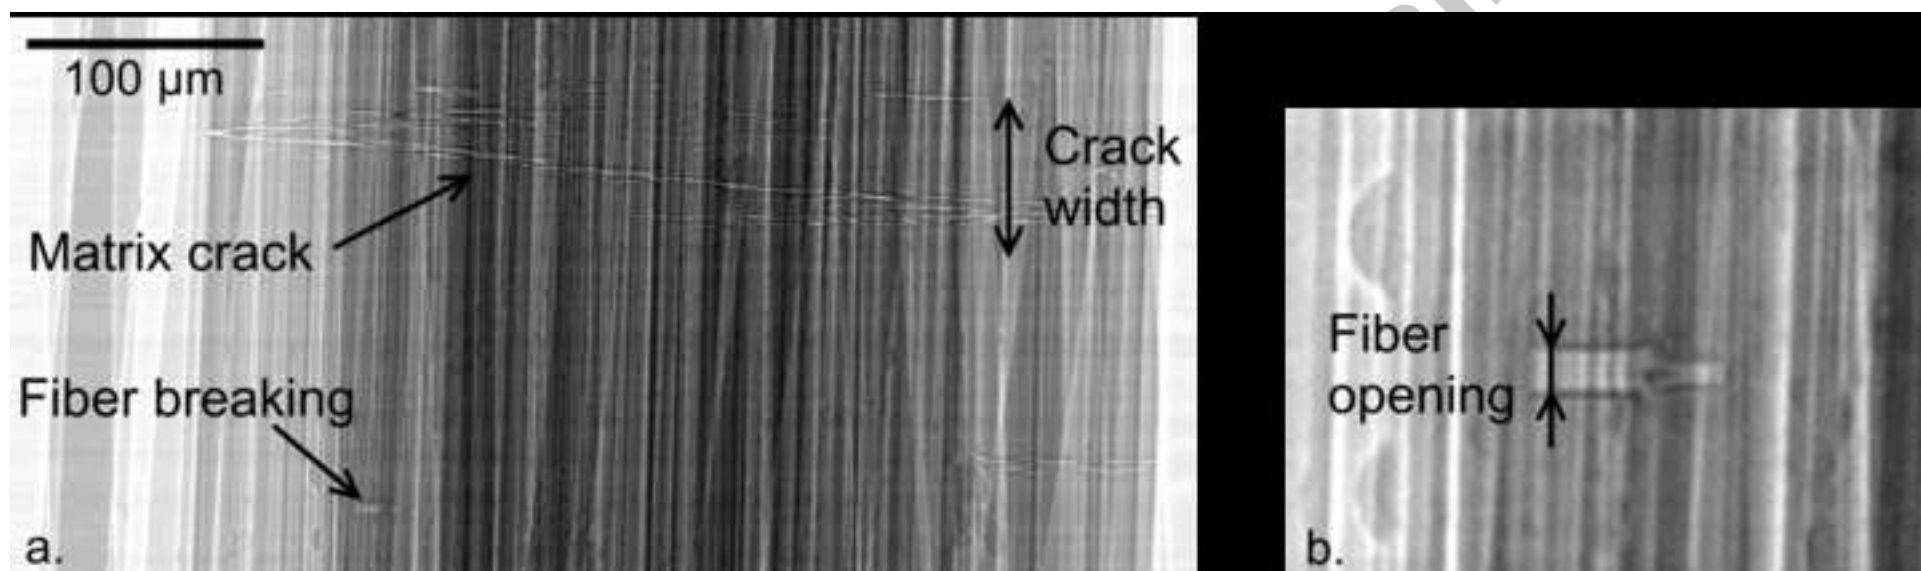
Figure 6

In order to study fiber break distribution under load (92 N) and after failure, simple radiographs were useful to locate both fiber failures and main matrix cracks along the entire minicomposite length, as shown on figure 6a. While a few minor cracks were detected (they were harder to find on those images), they were not reported here. The detection was limited to visual observation leading to an inventory of fiber break and main matrix crack positions. Fiber crack openings and crack widths, as defined in section 1.3.1, can also be estimated (figure 6).

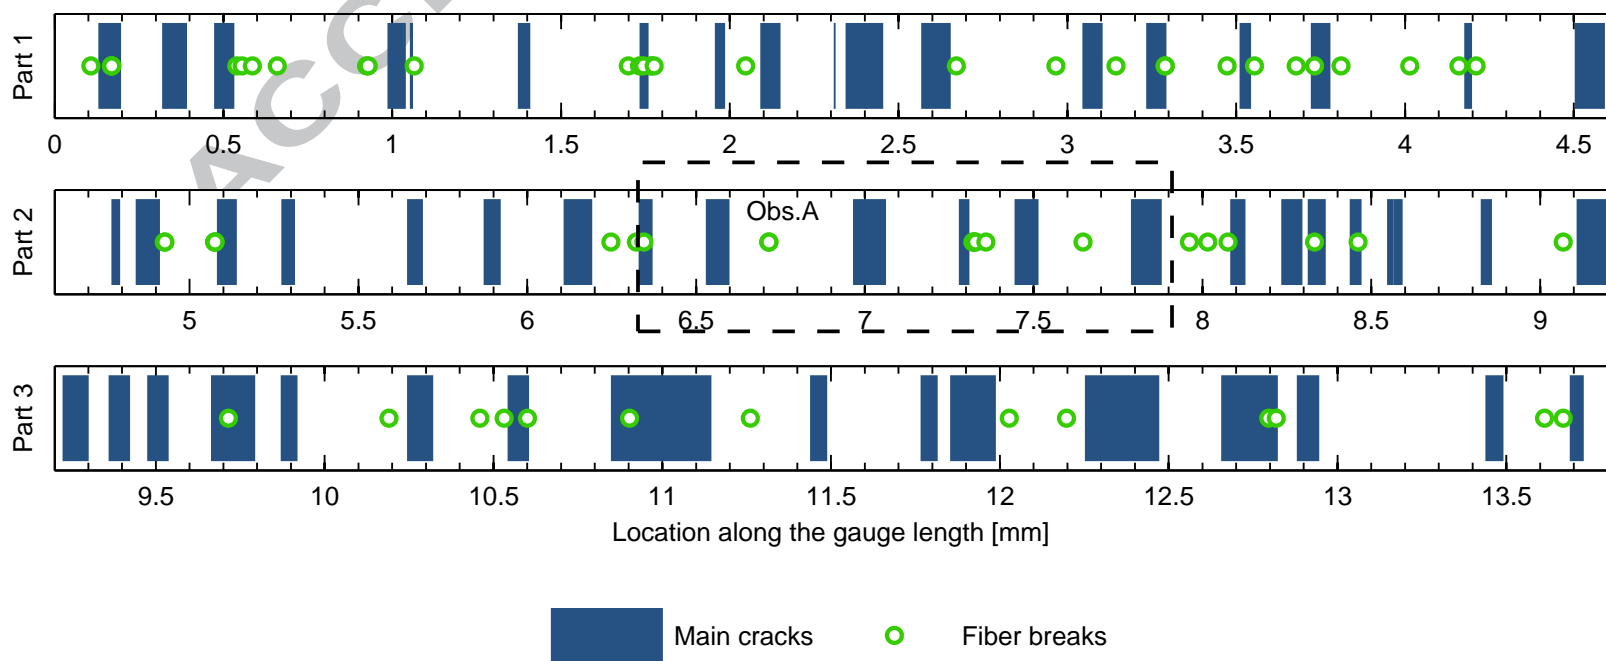
Figure 7

Figure 7: Damage location along the entire minicomposite at 92 N as detected from the radiographs (obs. B). Blue line widths are directly related to crack widths. The minicomposite part focused on by observation A is framed with a dashed line.

The axial distribution of main matrix cracks and fiber breaks (as defined in section 1.3) are presented in figure 7 from radiograph observation performed at 92 N of the entire minicomposite (obs. B). At this loading, the matrix cracking can be assumed to be completed (see figure 2) so the average intercrack distance at saturation of crack number density was estimated to be equal to 250 μm . This value is consistent with crack spacing distances measured on similar minicomposites after classical tensile tests [3] (173 μm to 350 μm). The field of view of the tomography observations (obs. A) is also reported in figure 7. Before studying matrix crack morphology and propagation in detail, the evolution of the damage axial distribution was investigated by visual detection in the CT-reconstructions for the six different loading levels (figure 8). A first observation is that most cracks evolve when the load is increasing, in the sense that their width, as defined before, increases. Moreover, some of the minor cracks developed into main cracks, but the majority remained isolated.

Radiographs resulting from observations B and C lead to statistical data about fiber breaking along the minicomposite under loading (92 N) and after failure. Following figure 7, fiber breaks appeared homogeneously along the minicomposite, mostly located in the vicinity of the matrix cracks. The fiber break density was rather low, with 4.8 broken fibers per mm (ie less than 1% fibers per mm).

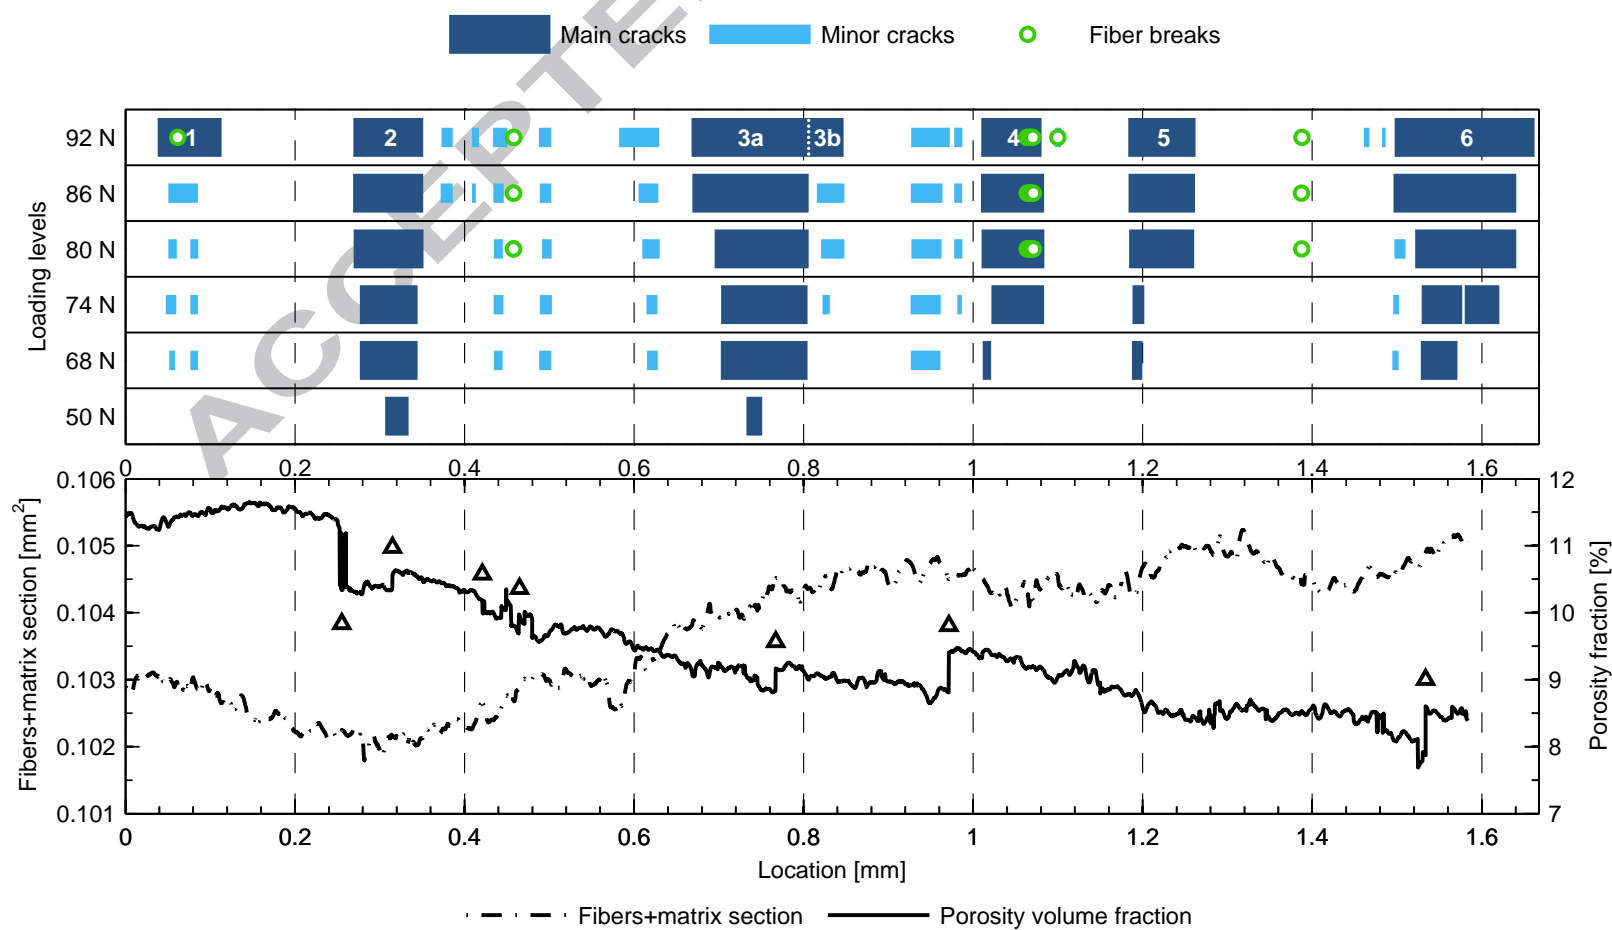
Figure 8

Figure 8: Damage location along the minicomposite in the area observed by tomography for the 6 successive loading levels (obs. A) compared to the variations of the effective section (fibers and matrix, without porosity) and the surface porosity fraction. Triangular markers point out peripheral pore openings or closings.

The damage distribution is then compared with the effective section and surface porosity fraction variations in the axial direction (figure 8). The purpose is to study a potential link between damage location and these global characterizations of the microstructure. Both were estimated from a threshold of the holotomographic image.

These observations did not evidence any clear link between crack locations and these global microstructure quantifications. Crack locations do generally not coincide with local extrema of effective section or porosity. Crack 2 is an exception, as it coincides with a local minimum of the effective section and thus a local maximum of average axial stress, but this is far from a general features.

Additionally, observation A shows that the first fiber breaks observed with 3D tomography appeared at 80 N (figure 8). This load matches the final stage of matrix crack propagation inside the minicomposite.

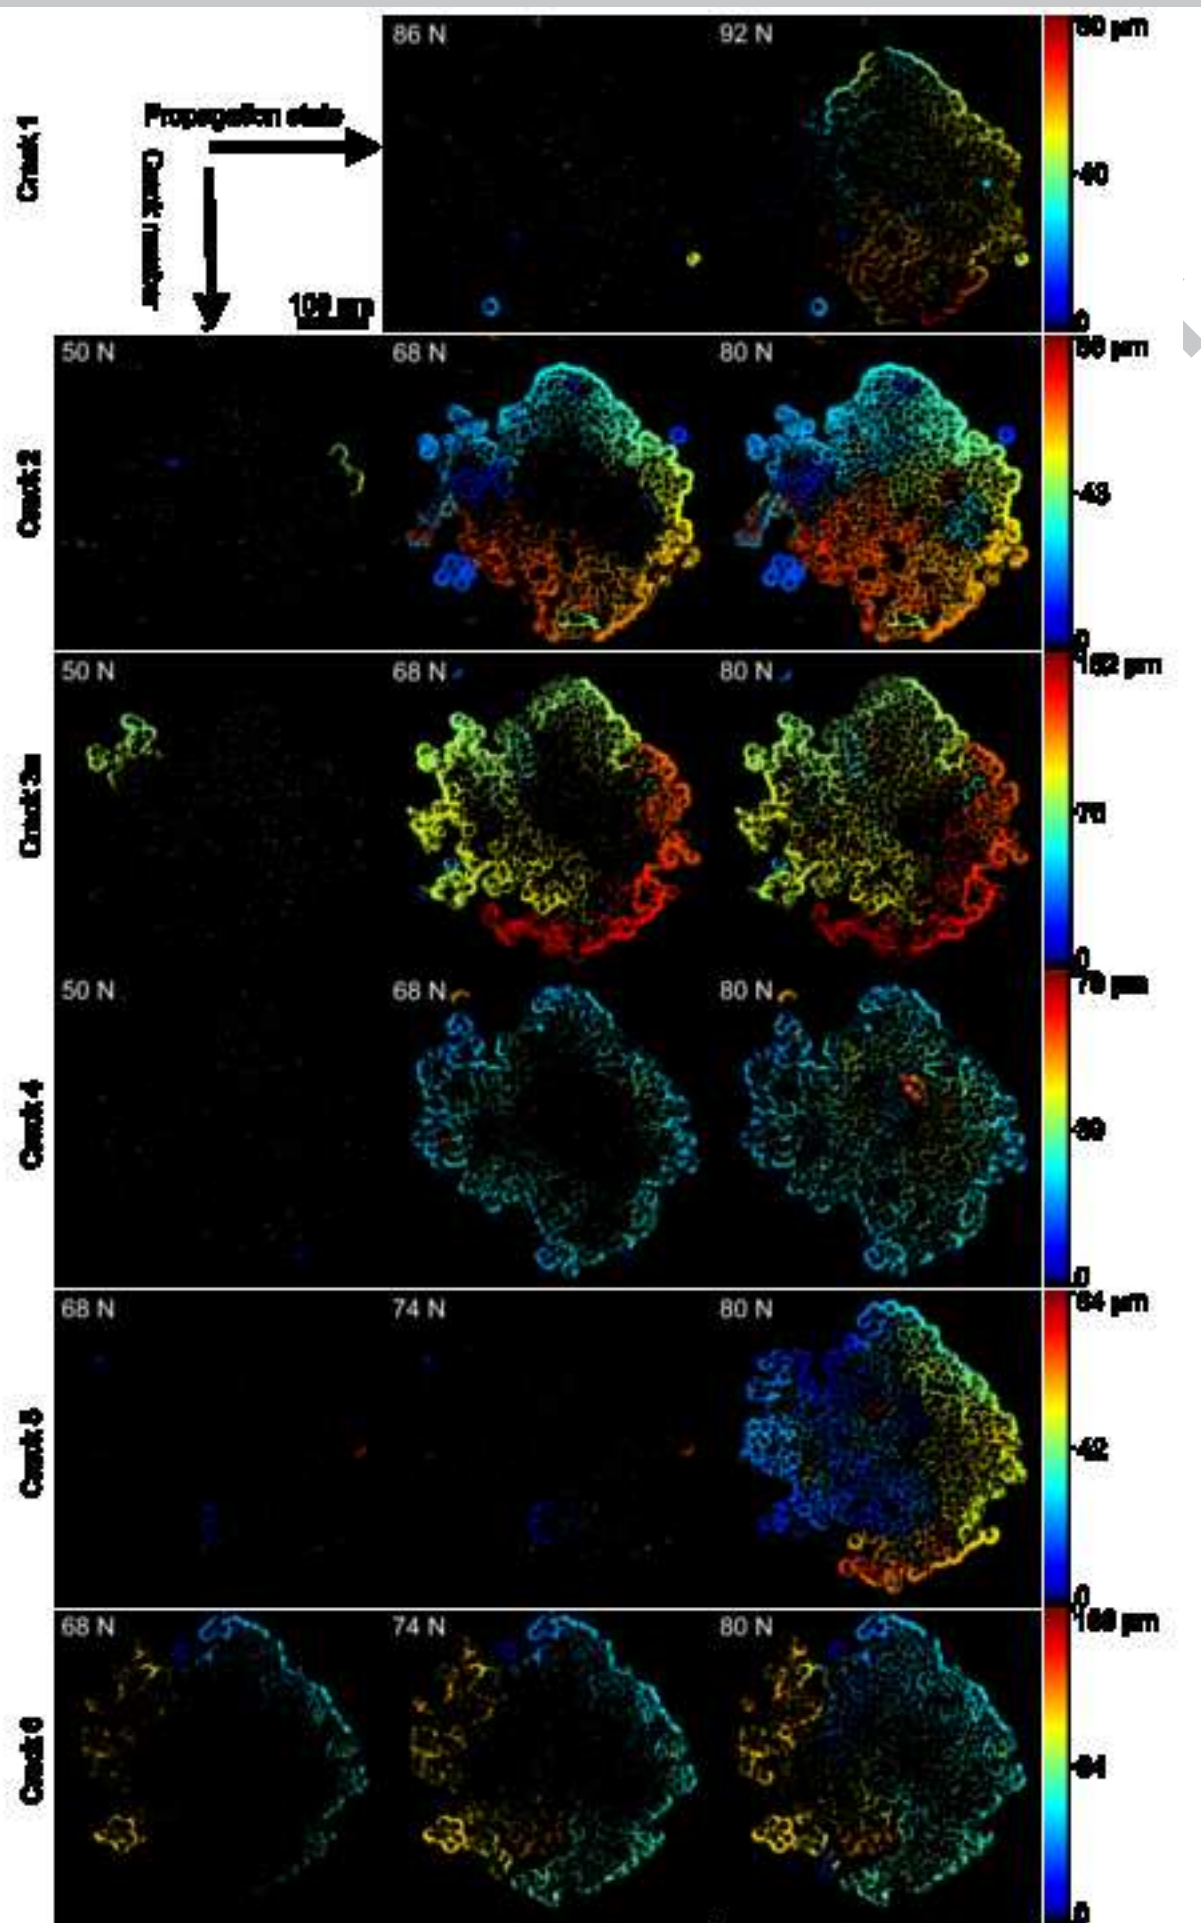
Figure 9 - color

Figure 9: Results of main crack detections (projections onto the transverse plane). Color scale corresponds to the local height of each cracked voxel (with respect to the lower face of each sub-volume). Note that scale is different for each crack.

The automatic procedure described in section 1.3 was used to detect the six main cracks, numbered in figure 8, for all of the six loading levels applied during observation A. Six sub-volumes, centered on the six main cracks observed at 92 N, were defined to compute the detection. Figure 9 describes the 3D geometry of the six detected cracks, in the form of the height Z of each crack as a function of the (X,Y) positions on the transverse plan. Only loading levels indicating crack propagation are presented (for example crack 2 did not propagate between 68 N and 74 N).

Concerning the crack morphology at 92 N, all six main cracks spread across the entire minicomposite section. They are not flat and typically follow a spiral shape around the fiber direction, except for crack 4 which presents an axial symmetry. Note also that the

Pertaining to crack propagation, two or three distinct propagation states were observed depending on the crack. For example, cracks 2, 3, 4 and 6 propagation states followed three typical steps: crack initiation in a localized peripheral zone of the minicomposite, crack propagation on the entire periphery, and finally, propagation towards the section center. Crack 5 also initialized on the periphery, but the intermediate propagation state was not caught during observations. Lastly, although it was not revealed by the detection process, crack 1 initiation was visually detected and occurred inside the minicomposite section at 86 N.

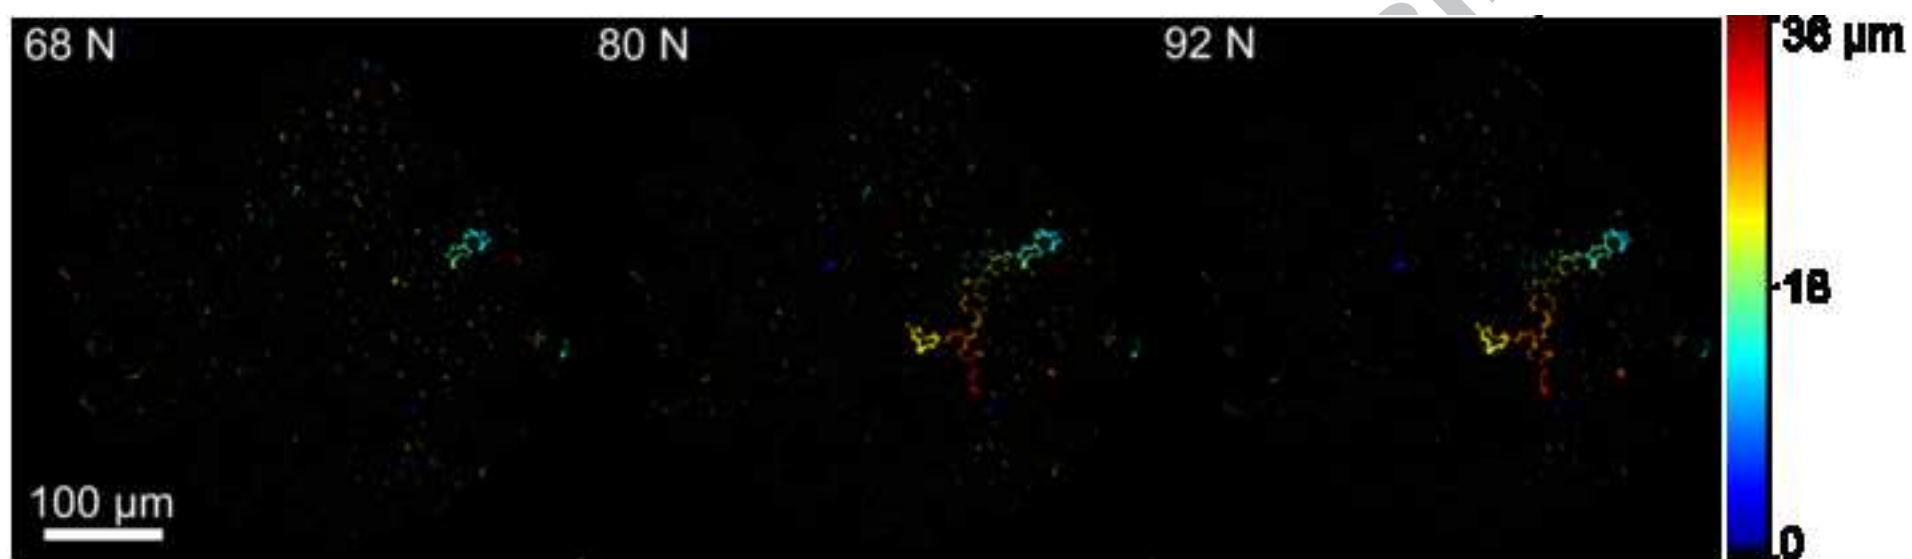
Figure 10 - color

Figure 10: Projection onto the transverse plane of crack 3b, which is an extension of the main crack 3a.

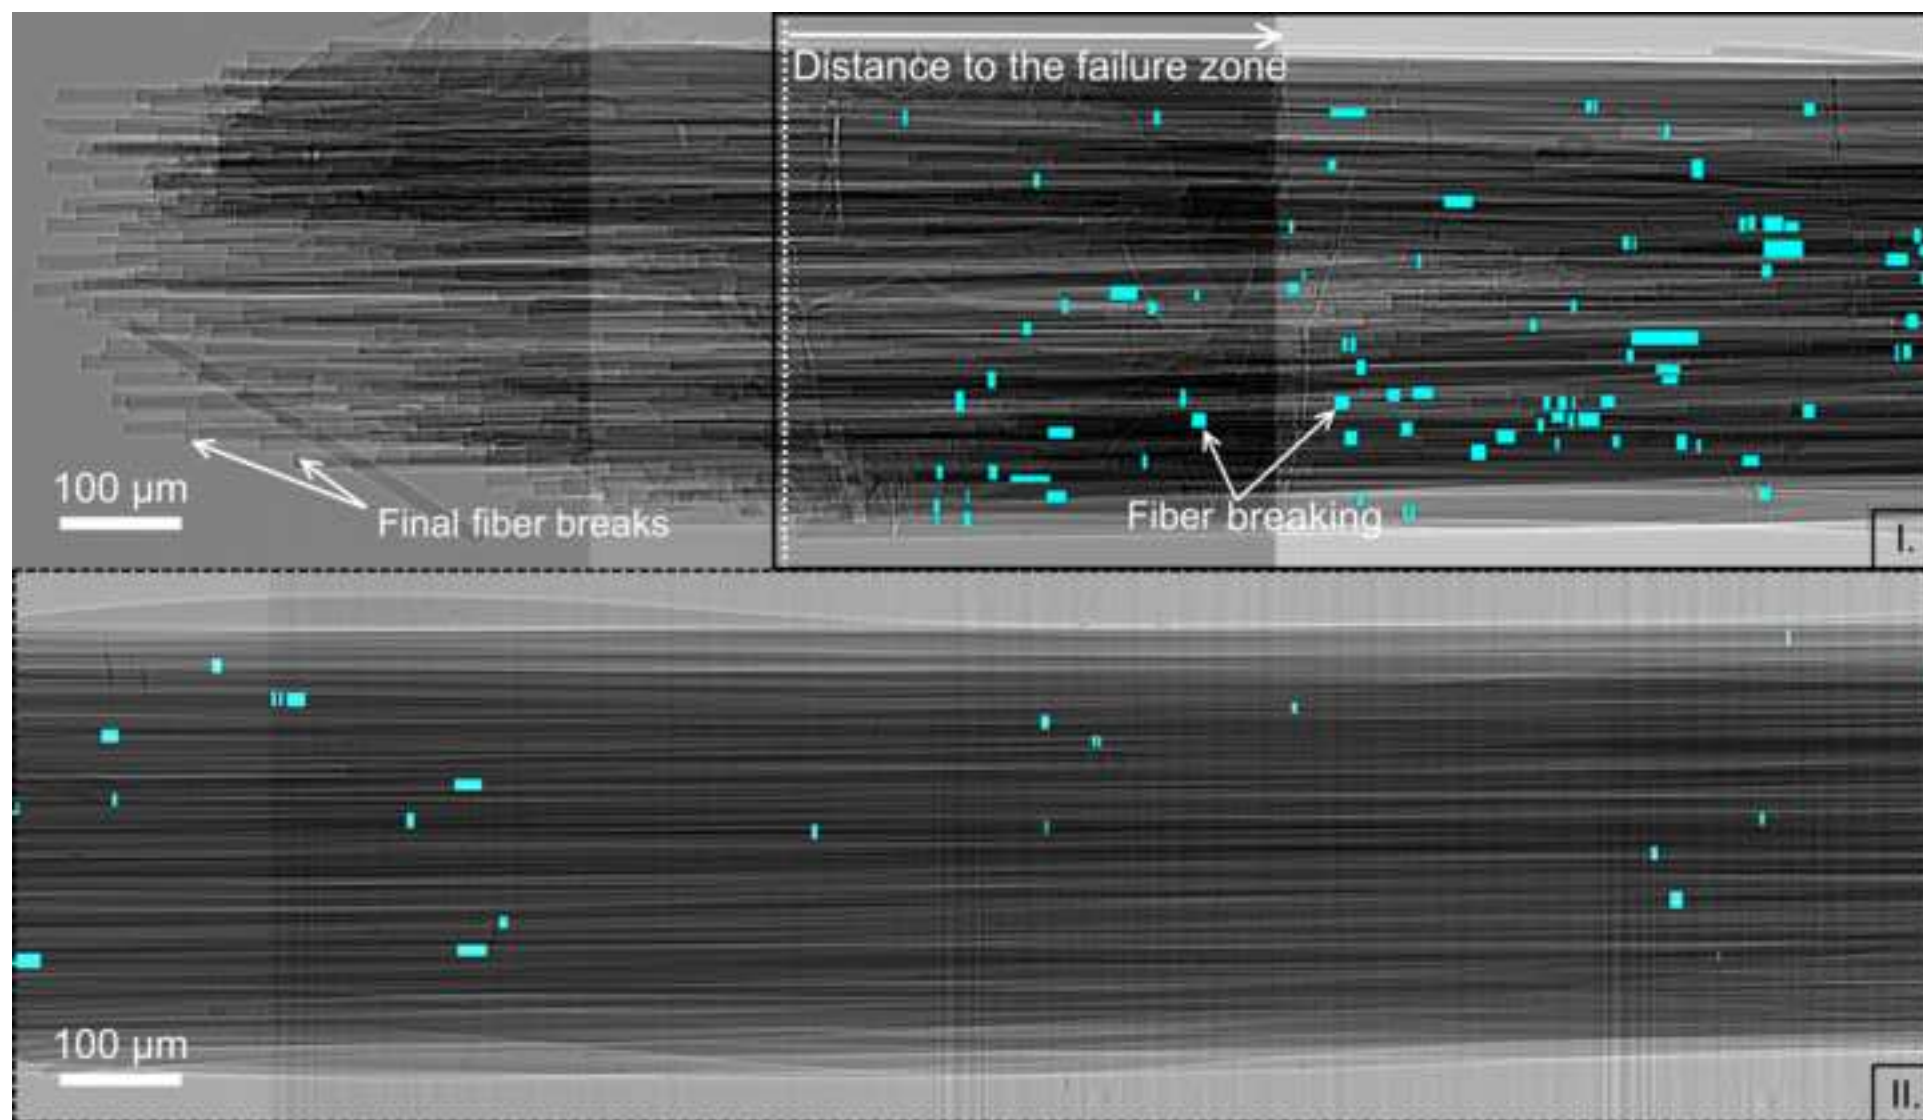
Figure 11

Figure 11: Radiographs after failure located near (I.) and far from the ultimate failure zone (II.) (see figure 12). Fiber breaks are highlighted.

Considering post-failure observations without counting final breaks (figure 11), approximately 220 fiber breaks were observed in the 12 mm long half minicomposite.

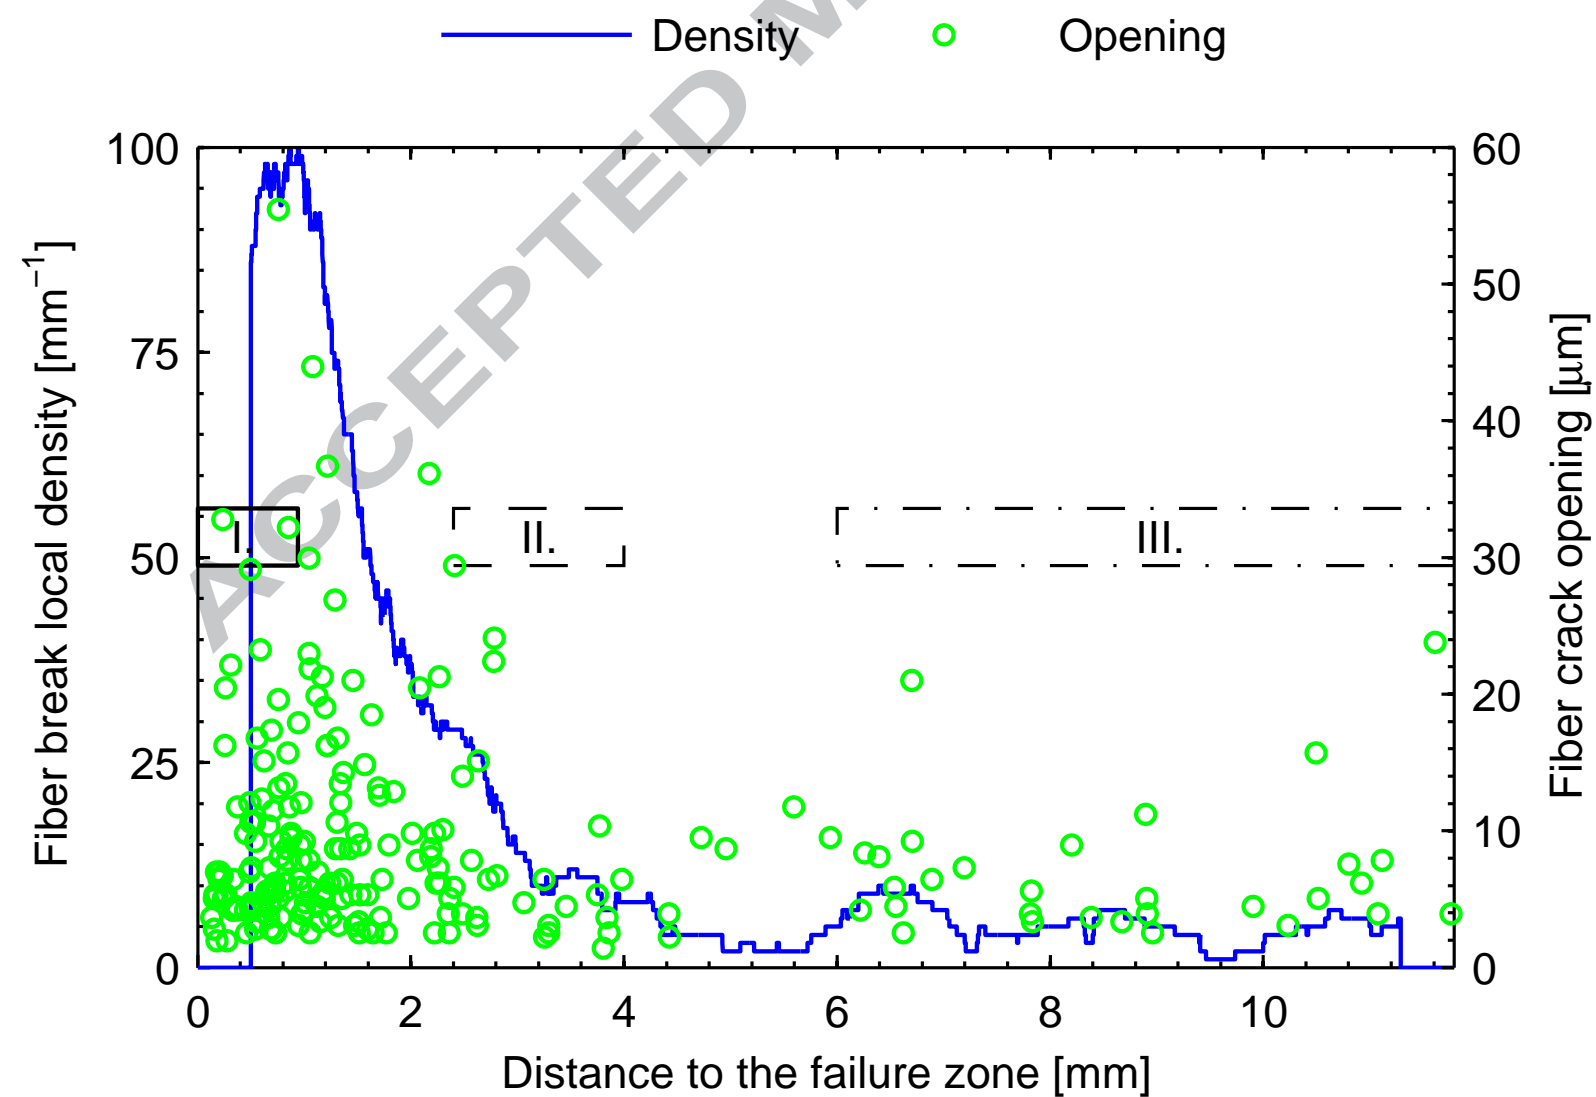
Figure 12

Figure 12: Fiber break local density and opening as a function of the distance to the ultimate failure zone. The local density was computed over a 1 mm moving window.

Regions I. and II. designate radiograph locations presented in figure 11. Region III. is the minicomposite part far from the failure zone when crack density appears uniform.

The break density is far less homogeneous (figure 12). In fact, most fiber breaks are located within 2 mm of the failure zone. On the other hand, the fiber break distribution is quite homogeneous at other locations. It has a density of approximately 5 breaks per mm (calculated on region III in figure 12), very similar to the density at 92 N.

In agreement with these observations, two different scenarios could be proposed. On the one hand, a random uniform fiber breaking develops slowly as the stress increases and the localization of the fiber density observed on figure 12 is the consequence of dynamic effects during failure. On the other hand, the random fiber breaking starts with a uniform distribution, then a localization of the break density occurs and leads to the ultimate failure. This second scenario is in better agreement with the final slight non-linearity observed on macroscopic curves, but additional experiments are required to
